# Electromagnetic transients and failed upward leaders observed during lightning activity in an onshore wind farm

**Abstract**—At a wind farm in Croatia, lightning activity is monitored across the entire site using a lightning location system, and on a single wind turbine equipped with a Rogowski-coil-based current measurement system and a high-speed camera, all independently GPS-synchronized. In addition to recording lightning flash currents on the monitored turbine, the system is frequently triggered by electromagnetic disturbances caused by nearby lightning flashes. These include direct flashes to two neighboring turbines that share the same cable connection to the substation and have interconnected grounding systems with buried bare conductor, as well as cloud-to-ground flashes to soil near cable routes, where the resulting electromagnetic fields couple onto the cables, causing surges to propagate to the monitored turbine. The camera occasionally captures failed upward connecting leaders from the monitored turbine during these lightning events. This paper presents three cases of flashes to two neighboring wind turbines and two cases of cloud-to-ground flashes to nearby soil, a

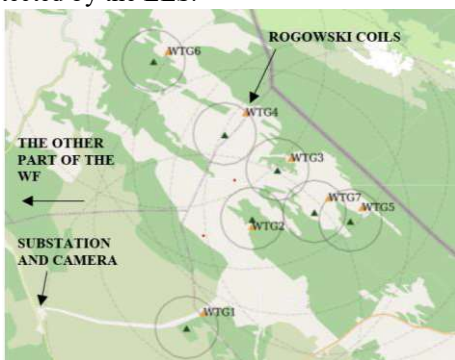
Figure 1 shows a map view of the WF, illustrating the northwest section of the 110/20 kV substation and comprising seven WTs. These WTs, each rated at 3 MW, have a tower height of 132 m and 49 m-long blades. While only seven WTs are shown on the map, an additional batch of seven WTs is located west of the substation, outside the displayed area. The map highlights a smaller circle for each WT, representing their equivalent collection areas with a radius three times the WT height (396 m), as per IEC 61400-24 [19]. A lightning strike identified by the LLS within the equivalent collection area is considered to have struck the respective WT. LLS data is used for continuous monitoring of lightning activity, generating weekly statistics and spatially correlating lightning flashes with specific WTs. This correlation is performed for each WT. The orange triangles indicate the actual locations of the WTs, while the green triangles represent corrected positions, adjusted to compensate for the LLS location bias (toward the southwest), ensuring accurate spatial correlation of lightning strokes detected by the LLS.

Fig. 1. Map view of the WF showing the section northwest of the 110/20 kV substation, which includes 7 WTs.

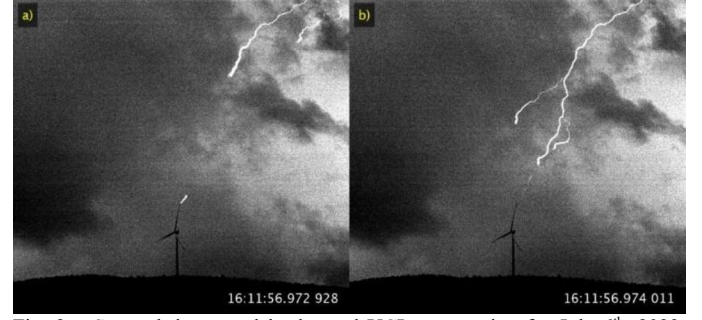
Figure 2 shows two frames from the initial stages of the event, spaced approximately 1 ms apart. These frames clearly illustrate the progression of the downward leader from the cloud and the upward connecting leader initiated from the WT blade, moving towards each other. Figure 3 (left) represents the moment when a sudden increase in luminance occurred on the right side of the HS camera frame as the downward leader approached WTG4. After this moment, the leader began to withdraw and gradually faded away, ultimately failing to connect to WTG4. According to the HS camera's timestamp, the sudden and intense increase in luminance occurred at 16:11:56.975 UTC. This coincided with the moment the LLS registered a stroke hitting the WTG3 to the right of WTG4 (from the camera's perspective) and another stroke hitting WTG6 (left from the camera's perspective). Figure 3 (right) shows the exact locations of the two strokes as determined by the LLS, marked with red crosses. According to LLS, the WTG6 stroke occurred at 16:11:56.975 UTC, while the WTG3 stroke occurred 16:11:56.974 UTC.

Fig. 2. Stepped downward leader and UCL progression for July 6<sup>th</sup>, 2023, lightning flash event.

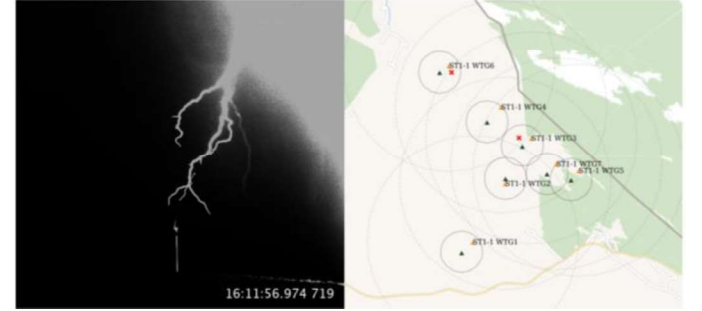
Fig. 3. HS camera frame when the luminance suddenly increased (left); Lightning flash activity recorded by LLS in that area at that exact time (right).

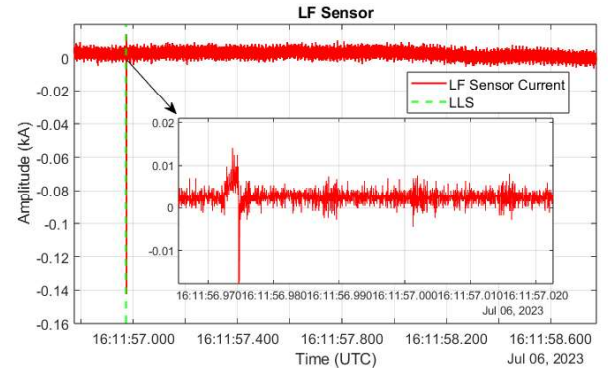
The camera was triggered by the current measurement system. In this instance, the system potentially registered a continuous current associated with an initiated UCL, as shown in Figure 4. Immediately afterward, an electromagnetic transient was observed, caused by a lightning stroke to WTG3. The timing of this stroke, as determined by the LLS, is marked by the vertical line in the figure. Only the timing of the stroke that impacted WTG3 is plotted. No records from the HF sensor are available for this event.

Fig. 4. LF sensor record of July 6<sup>th</sup>, 2023, lightning flash event: potential continuous current immediately followed by electromagnetic disturbance.

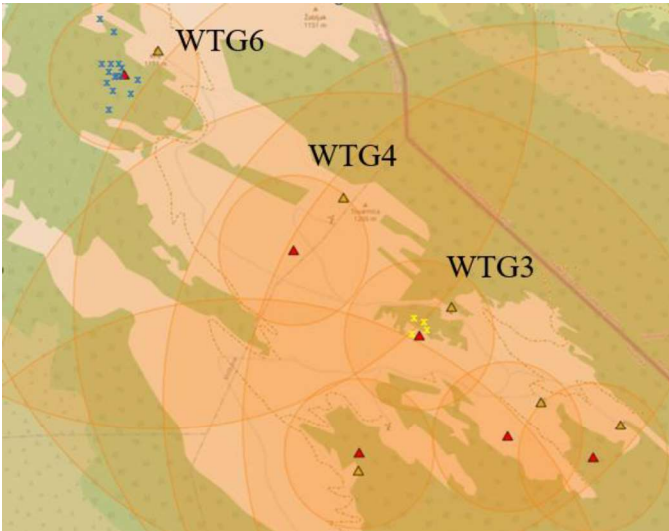
Figure 5 shows the LLS spatial data associated with December 11<sup>th</sup>, 2022, lightning flash to WTG6, which includes 15 successive strokes located in the collection area of the WT (marked with blue cross), and data associated with the January 21<sup>st</sup>, 2023, lightning flash to WTG3, which includes 4 successive strokes located in the collection area of the WT (marked with yellow cross).

Fig. 5. December 11<sup>th</sup>, 2022, lightning flash to WTG6: 15 strokes (marked with blue cross); Jan 21<sup>st</sup>, 2023, lightning flash to WTG3: 4 strokes (marked with yellow cross).

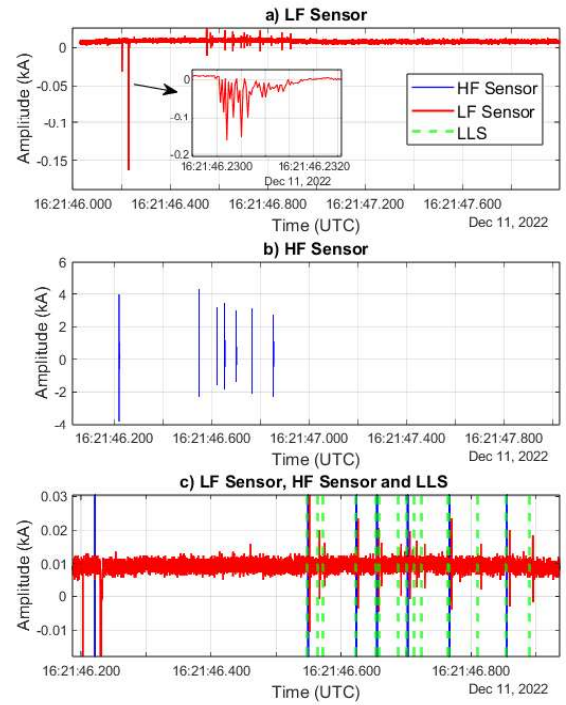
The lightning flash to WTG6 on December 11<sup>th</sup>, 2022, occurred at approximately 16:21:46 UTC. Figure 6 presents data collected by the LF and HF sensor at WTG4, highlighting the electromagnetic disturbances generated by this event. The figure includes a 2-second LF sensor measurement capturing the entire event (Figure 6a), several 1.5-millisecond HF sensor measurements, each corresponding to the transient caused by an individual stroke (Figure 6b), and a combined plot of LF and HF sensor measurements annotated with vertical lines marking the timings of strokes detected by the LLS (Figure 6c). The figure is zoomed in on the y-axis to enhance the visibility of the LF sensor disturbances. Figure 6 further illustrates the HF sensor records by plotting them together, aligned to time zero, to emphasize the similarity of the electromagnetic disturbances in shape and duration. After a stroke occurs on WTG6, an associated electromagnetic disturbance is detected by the current measurement system (HF and LF sensors) in about a millisecond.

The LF sensor captured all the electromagnetic disturbances that reached WTG4, as clearly shown in Figure 6c, where almost every local peak on the LF sensor corresponds to the time the LLS detected a stroke to WTG6. The first two peaks on the LF sensor are probably not associated with disturbances caused by strokes and they may instead be linked to the continuous current from UCL. However, there is no camera data for this case, as the camera was not yet been installed.

Out of the total 15 CG strokes, the HF sensor picked up electromagnetic transients associated with six. The remaining transients likely did not have sufficient intensity upon reaching WTG4 to trigger the measurement system. As shown in Figure 6, there are seven HF sensor records in total; however, the first record contains a disturbance not associated with any stroke detected by the LLS. This is further confirmed by Figure 7, which illustrates that this first disturbance captured by the HF sensor differs significantly from the other electromagnetic disturbances in terms of duration and shape.

Fig. 6. Electromagnetic transients at WTG4 caused by December 11<sup>th</sup>, 2022, lightning flash to WTG6, as recorded by the LF and HF Rogowski coils.

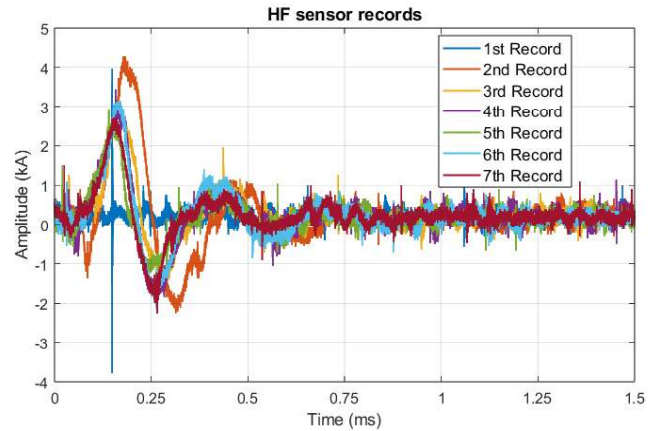
The remaining transients generally follow a consistent pattern, both in shape and duration (several hundred microseconds).

Fig. 7. HF sensor records of electromagnetic transients caused by the December 11<sup>th</sup> lightning flash to WTG6, aligned to time zero.

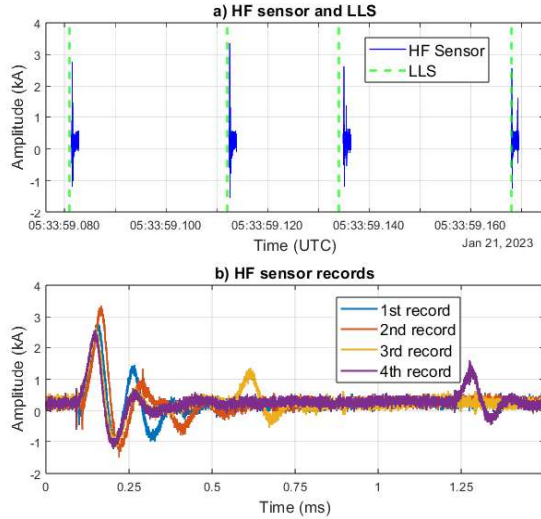
The lightning flash to WTG3 on January 21<sup>st</sup>, 2023, occurred at approximately 05:33:59 UTC. Figure 8 presents data collected during this event, including a combined plot of HF sensor measurements annotated with vertical lines marking the timings of strokes detected by the LLS (Figure 8a) and a plot of all HF sensor records aligned to time zero to emphasize their similarities in waveform shape and duration (Figure 8b).

For this event, no LF sensor record is available as it was not triggered. The HF sensor, however, captured all electromagnetic disturbances associated with each of the four strokes detected by the LLS. There is approximately a 1 ms offset between the stroke and the corresponding disturbance detected at WTG4, except for the last case, where they are almost perfectly aligned. This discrepancy arises from the LLS

As shown in Figure 8, the disturbances during the initial phase exhibit similar oscillatory behavior, which gradually attenuates overtime. Notably, the third (orange) and fourth (purple) HF sensor records contain additional oscillations occurring later in the event.

Fig. 8. Electromagnetic transients at WTG4 caused by the January 21<sup>st</sup>, 2023, lightning flash to WTG3, as recorded by the LF and HF Rogowski coils.

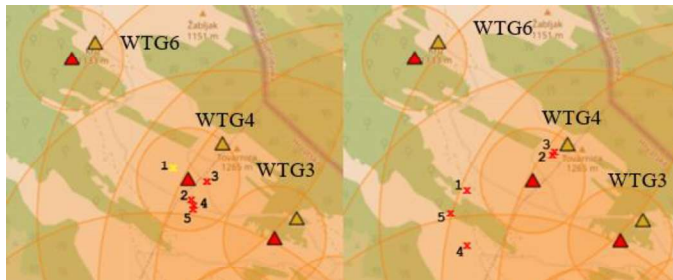
This section presents two examples of lightning flashes to nearby soil and the associated electromagnetic disturbances induced on cables and/or grounding systems, which propagated to WTG4. The examples include data from the current measurement system, HS camera recordings, and LLS data for the lightning flashes on September 3<sup>rd</sup>, 2024, around 13:55:35 UTC and April 25<sup>th</sup>, 2024, around 15:59:21 UTC. In both cases, the LF sensor measurements indicate the presence of continuous currents. However, the presence of continuous current associated with UCL is further confirmed only for the September 3<sup>rd</sup> event, as several HS camera frames clearly show the UCL initiated from the WT blade. Figure 9a illustrates the LLS spatial data associated with the CG lightning flash on September 3<sup>rd</sup>, 2024, while Figure 9b shows a similar CG flash that occurred on April 25<sup>th</sup>, 2024. In both cases, the strokes are numbered from 1 to 5.

Fig. 9. September 3<sup>rd</sup>, 2024, lightning flash (Figure 9a, left): April 25<sup>th</sup>, 2023, lightning flash (Figure 9b, right).

First, the September 3<sup>rd</sup>, 2024, lightning event will be analyzed. According to Figure 9a there were five discharges detected with the first one being classified as cloud-to-cloud (yellow cross). Figure 10 shows specific camera frames corresponding to moments around the times when the LLS detected strokes. In the top right corner of Figure 10 there are labels that associate each frame with specific LLS numbering of the stroke used in Figure 10a. Camera captured in total six strokes, one more than LLS as LLS missed the last one. Furthermore, the first stroke, which was categorized as cloud-to-cloud, appears to have hit the ground, as indicated by the first camera frame. From the frames the strokes used the same channel and discharged at the same ground strike point.

Now, the lightning event occurred on April 25<sup>th</sup>, 2023, will be analyzed. According to Figure 9b, five discharges were detected by the LLS. Despite the clear spatial separation of the discharges, they likely belong to a single flash, as the different ground strike points of the same flash can be several kilometers apart. Figure 13 shows specific HS camera frames corresponding to moments around the times when the LLS detected strokes. In the top right corner of each frame in Figure 13, labels are added to associate each frame with the numbering of strokes detected by the LLS in Figure 9b.

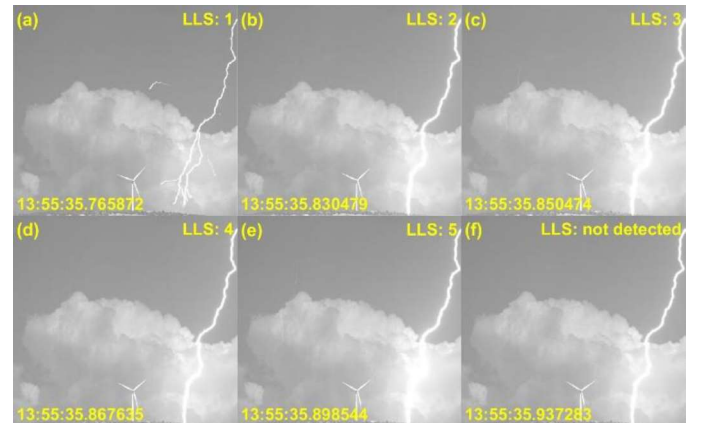
Fig. 10. September 3<sup>rd</sup>, 2024, lightning flash: HS camera captured failed UCL and six strokes in total.

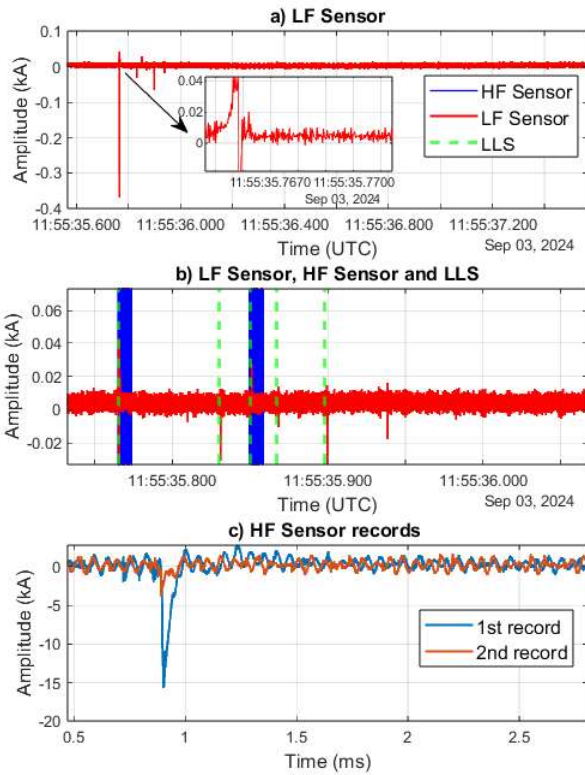
Figure 11 provides information about the electromagnetic disturbances caused by the lightning flash. Specifically, Figure 11a shows the LF sensor measurement of the event, indicating that a UCL occurred on the WT blade. However, the UCL failed, as indicated by the abrupt cessation of continuous current. Figure 12 displays two non-successive camera frames capturing the moment when the UCL was visible. Notably, the UCL and the associated continuous current faded as the flash made its initial connection with the soil. It should be noted that the UCL was visible in more frames than the two shown in Figure 12, but its appearance in the additional frames was much less distinct.

Figure 11b illustrates the LF and HF sensor measurements overlaid with vertical lines representing the LLS-detected stroke timings. As shown in Figure 11b, each vertical line corresponding to an LLS-detected stroke aligns with a local disturbance captured by the LF sensor. The HF sensor detected electromagnetic disturbances associated with two out of the five strokes detected by the LLS: the first and third stroke, following the numbering used in Figure 9a.

These transients are presented in greater detail in Figure 11c, where the corresponding, originally 9-ms long, HF sensor records are displayed relative to each other, enabling better comparison of the waveform shapes of the measured disturbances. The transients exhibit a similar overall waveform shape. Compared to flashes occurring directly on neighboring wind turbines, the transients observed here have a shorter duration (around 0.1 ms) and are not as oscillating.

Fig. 11. Continuous current associated with failed UCL and electromagnetic transients at WTG4 caused by nearby CG flash to soil on September 3<sup>rd</sup>, 2024.

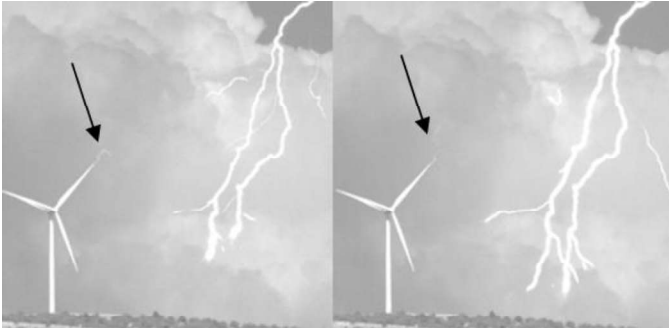
Fig. 12. Non-successive HS camera frames before the first connection, in which the UCL initiated from the blade, are visible.

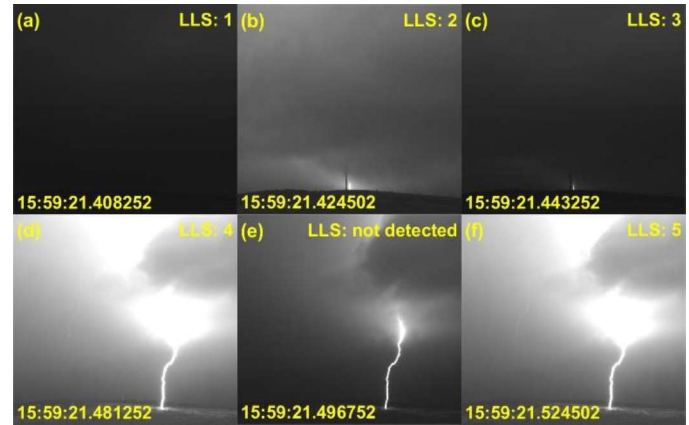
The first camera frame (a) corresponds to the first stroke detected by the LLS. For this stroke, neither the camera nor the measurement system registered any associated disturbance, suggesting that the stroke likely occurred farther away. Additionally, the camera detected one stroke not recorded by the LLS, occurring between strokes 4 and 5, as shown in

Fig. 13. April 25<sup>th</sup>, 2023, lightning flash: HS camera captured five strokes in total.

As indicated by the LF sensor measurement, it is likely that a UCL was launched during this event. However, it cannot be observed in the camera frames due to cloud cover obstructing a clear view of the WT blades. The timing of the measured continuous current corresponds approximately to the time of the frame (b) in Figure 13. In this frame, the cloud covering the upper part of the WT is clearly visible.

There are two HF sensor records – one is associated with the first flash behind the WT (camera frame (b) in Figure 13) and the other is associated with the first stroke in front of the WT (camera frame (d) in Figure 13).

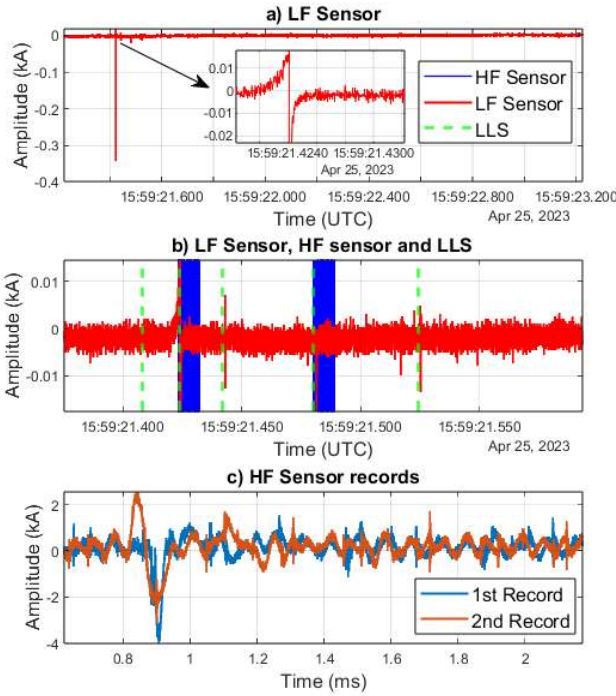
Figure 14 provides information collected by the current measurement system installed on WTG4 for this event. Specifically, Figure 14a shows the LF sensor measurement of the entire event, while Figure 14b overlays the HF sensor measurements onto the LF sensor data, with vertical lines indicating the timing of LLS-detected strokes. Figure 14c illustrates the HF sensor records aligned relative to each other for waveform comparison.

In Figure 14c, these events are presented in greater detail, where the corresponding 9-ms long HF sensor records are displayed relative to each other. The electromagnetic transient associated with HF sensor record 1, which corresponds to the stroke behind the WT, does not exhibit oscillations. In contrast, HF sensor record 2, representing the stroke in front of the WT shows more oscillatory behavior. Similar to the previous CG flash event to soil, the durations of these disturbances are shorter than those observed when one of the neighboring WTs is directly struck.

Fig. 14. Continuous current associated with failed UCL and electromagnetic transients at WTG4 caused by nearby CG flash to soil on April 25, 2023.
